# Managing 100 year old Pipeline

A City of Hamilton Case Study

#### The Beach Rd 900mm diameter Watermain

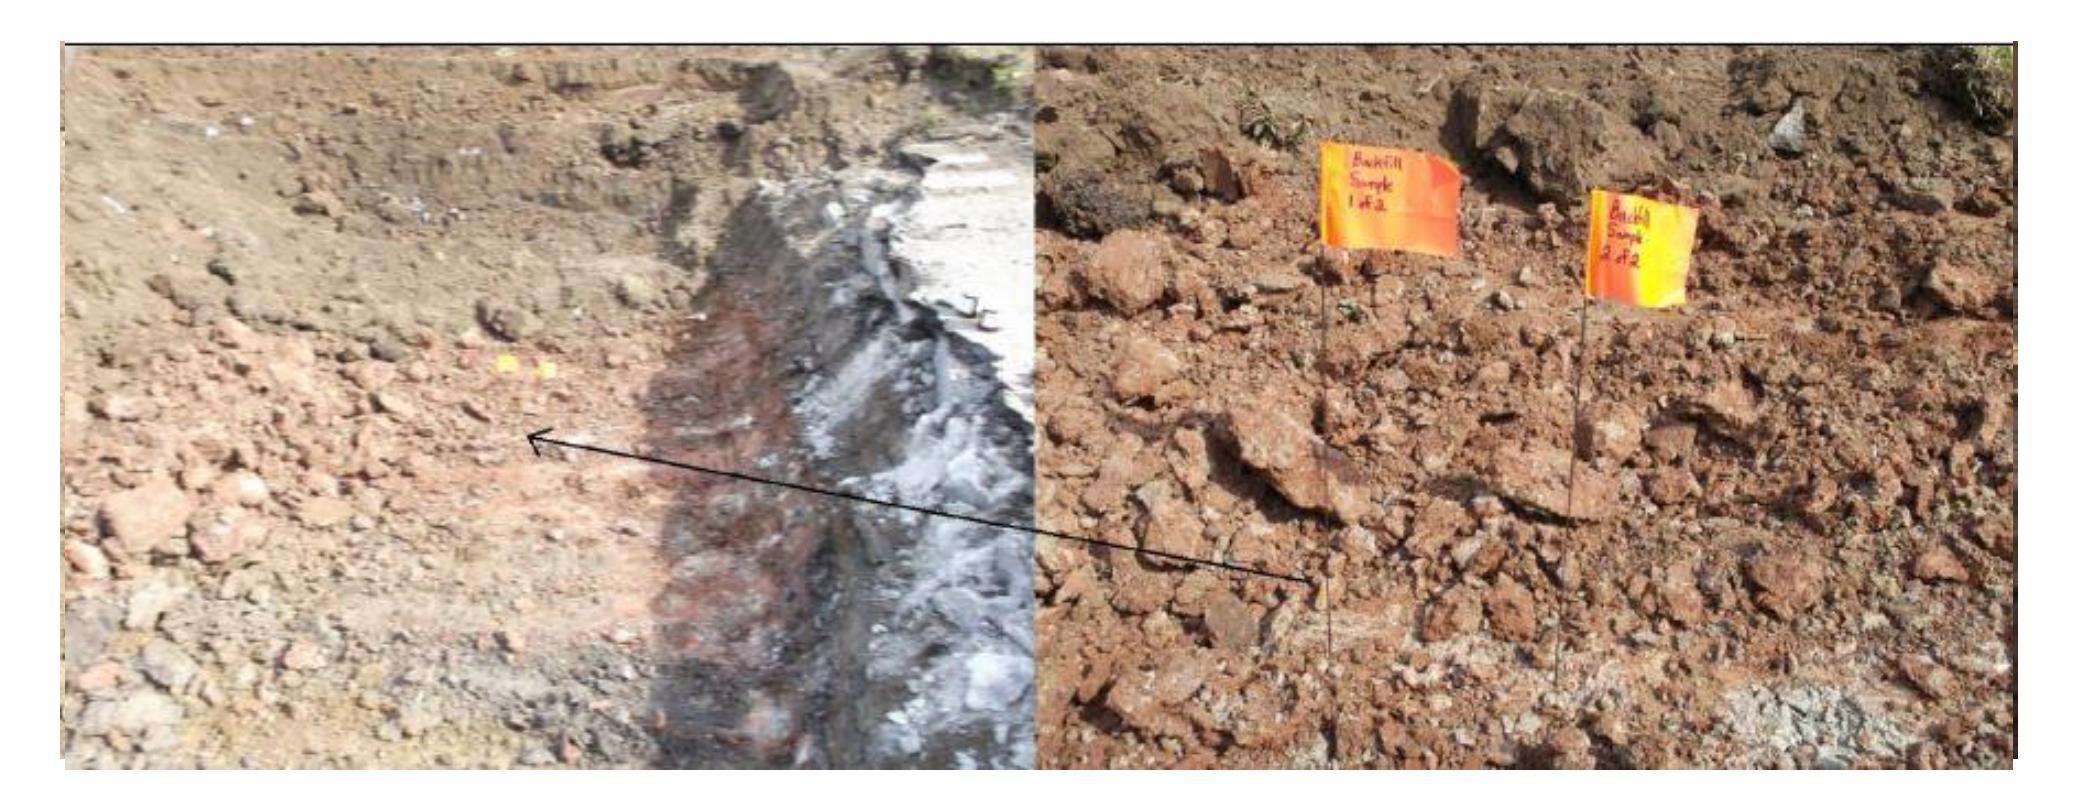
Site 1: Soil Bedding & Backfill

Moderately Corrosive

Sample Type	Soil Parameter	Value	Degree of Corrosivity
Backfill	Chloride	130 ppm	Mildly Corrosive
	рН	8.2	Non-Corrosive
	<b>Electrical Resistivity</b>	1851 ohm-cm	Mildly Corrosive
	Sulphate	200 ppm	Negligible
	Chloride	260 ppm	Moderately Corrosive
Podding	рН	8.1	Non-Corrosive
Bedding	Electrical Resistivity	1408 ohm-cm	Corrosive
	Sulphate	400 ppm	Negligible

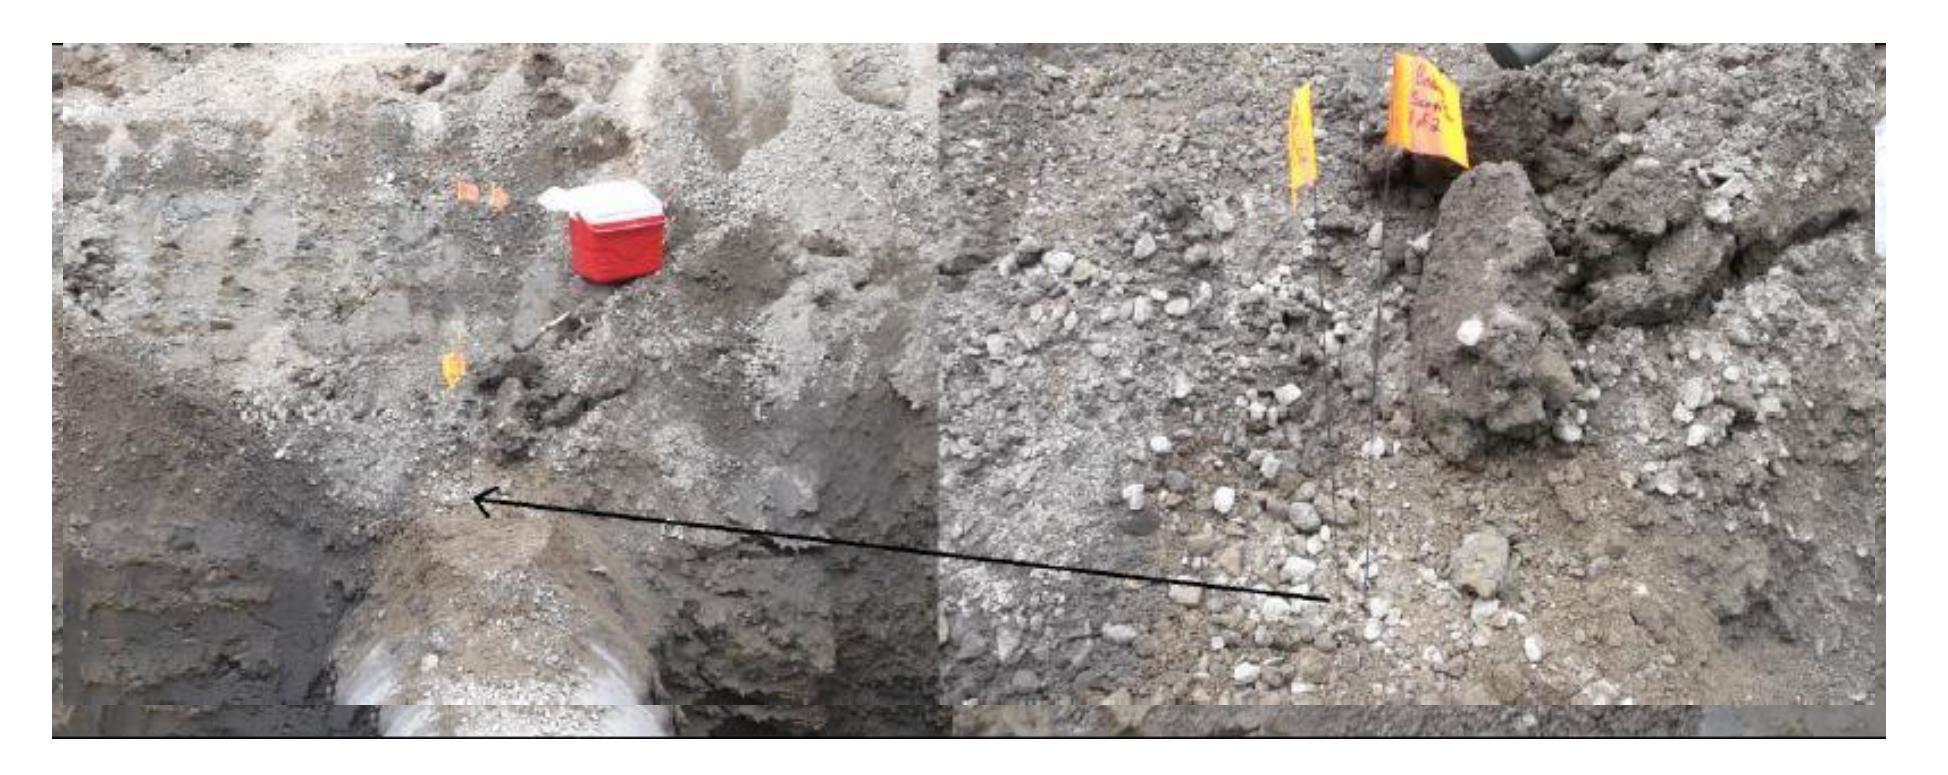
Site 2: Soil Bedding & Backfill

\*Moderately Corrosive

Sample Type	Soil Parameter	Value	Degree of Corrosivity
Backfill	Chloride	310 ppm	Moderately Corrosive
	рН	8.3	Non- Corrosive
	Electrical Resistivity	1298 ohm-cm	Mildly Corrosive
	Sulphate	400 ppm	Negligible
Bedding	Chloride	330 ppm	Moderately Corrosive
	рН	10.2	None (alkaline)
	Electrical Resistivity	952 ohm-cm	Corrosive
	Sulphate	4200 ppm	Negligible

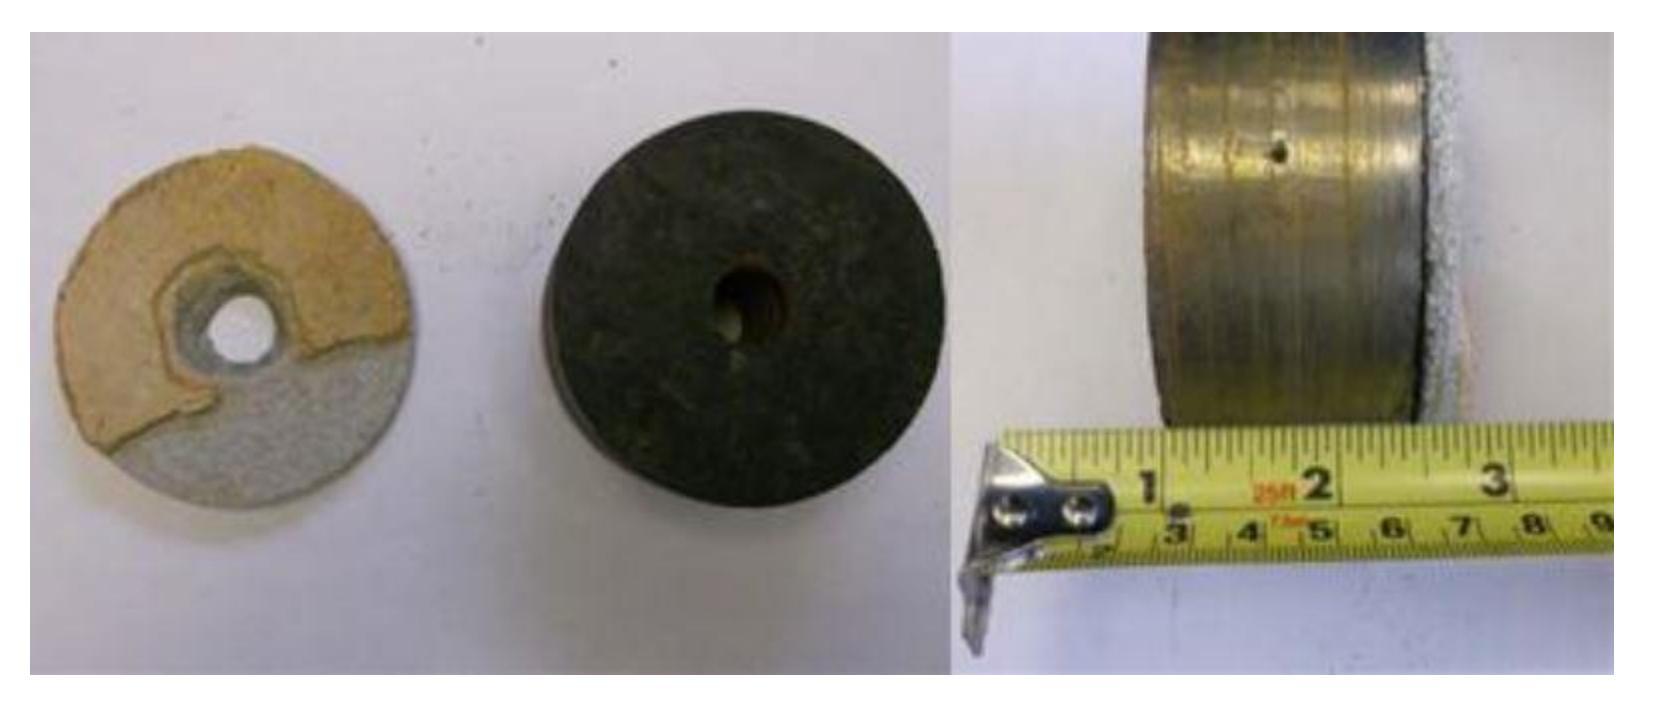
Site 1: pipeline material sample

In additional to taking a core sample at the Tire Site, a scratch test was also completed to inspect the exterior surface of the WM. Upon completion of the scratch test there were no signs of any surface degradation presence on the outer surface (i.e. no material broke or scraped off).

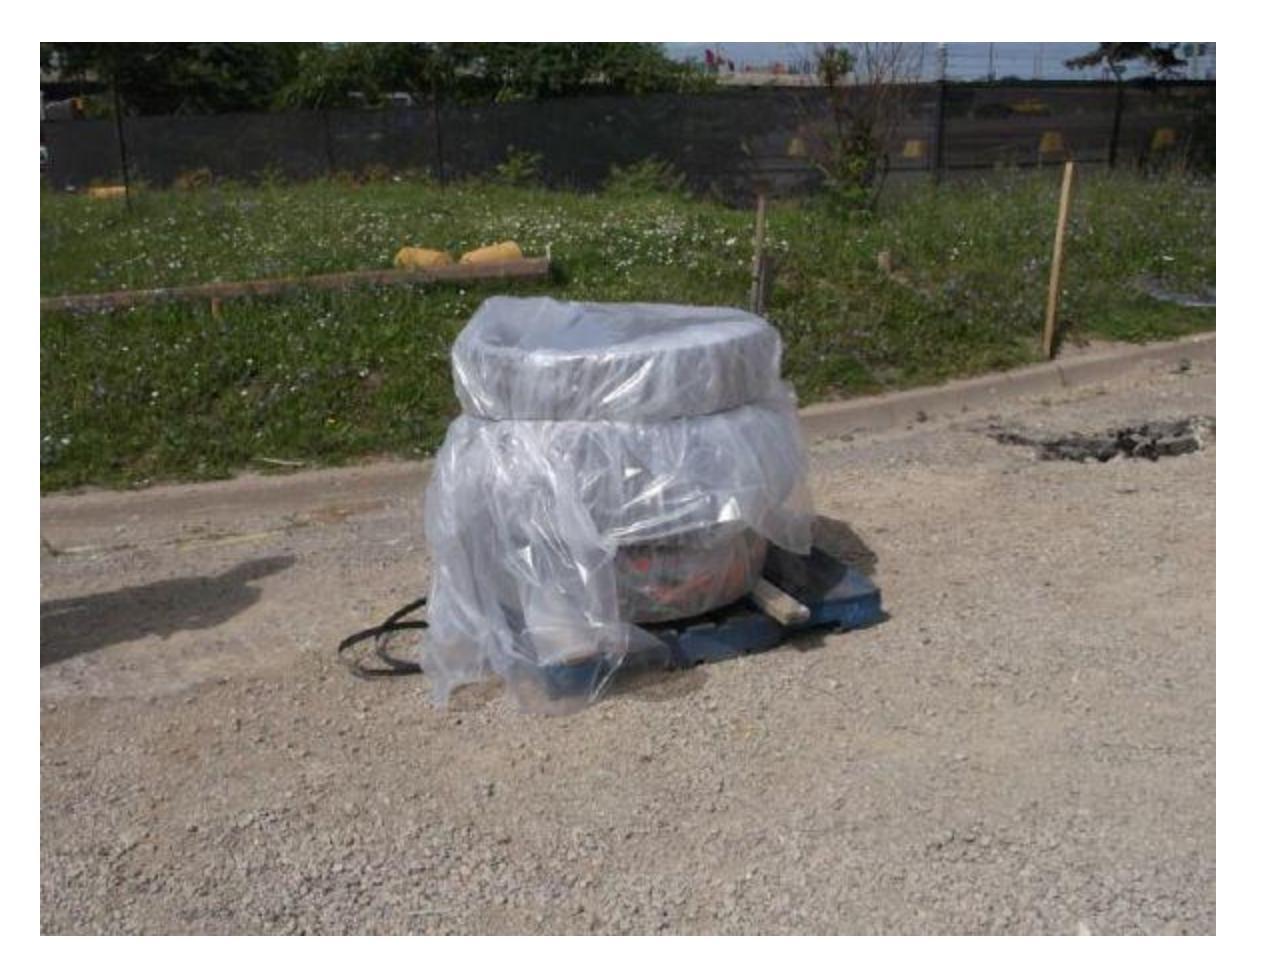
Site 2: pipeline material sample

- Thickness measurements
- Metallographic examination
- Thickness variance from 34mm to 45mm (11mm)
- Minimal pitting on both internal and external surfaces

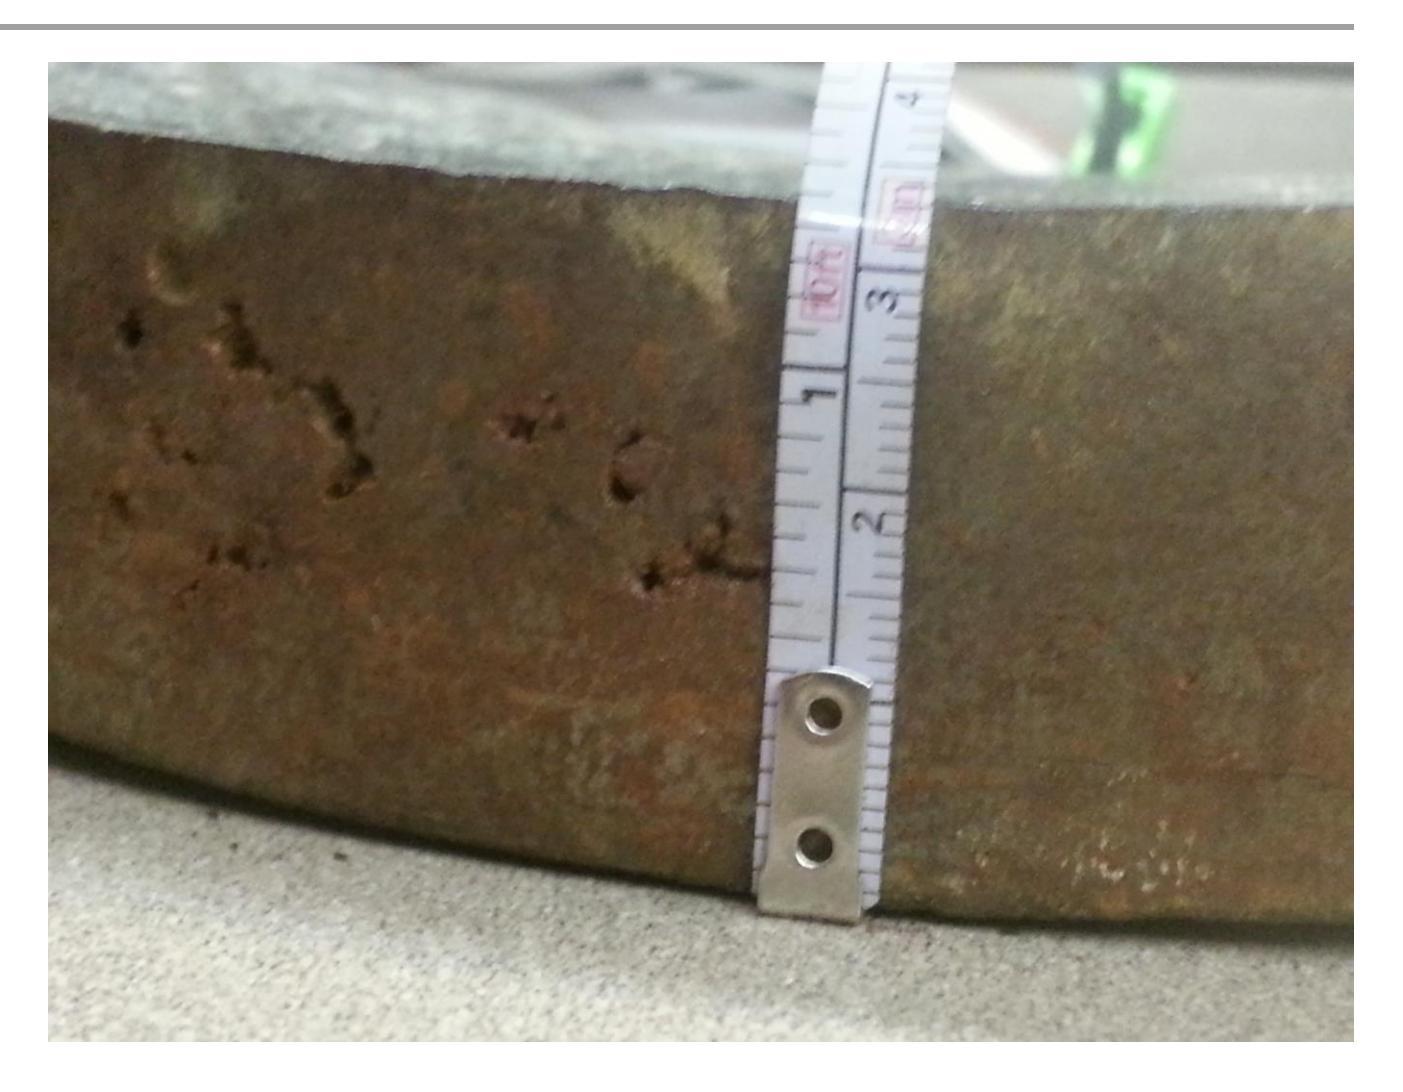
- Cross-sections were prepared in accordance with ASTM E3-11
- Little to no surface corrosion
- Little to no pitting
- Thickness measurements in accordance with the original design
- Mortar lining that was installed in 1960's was holding up

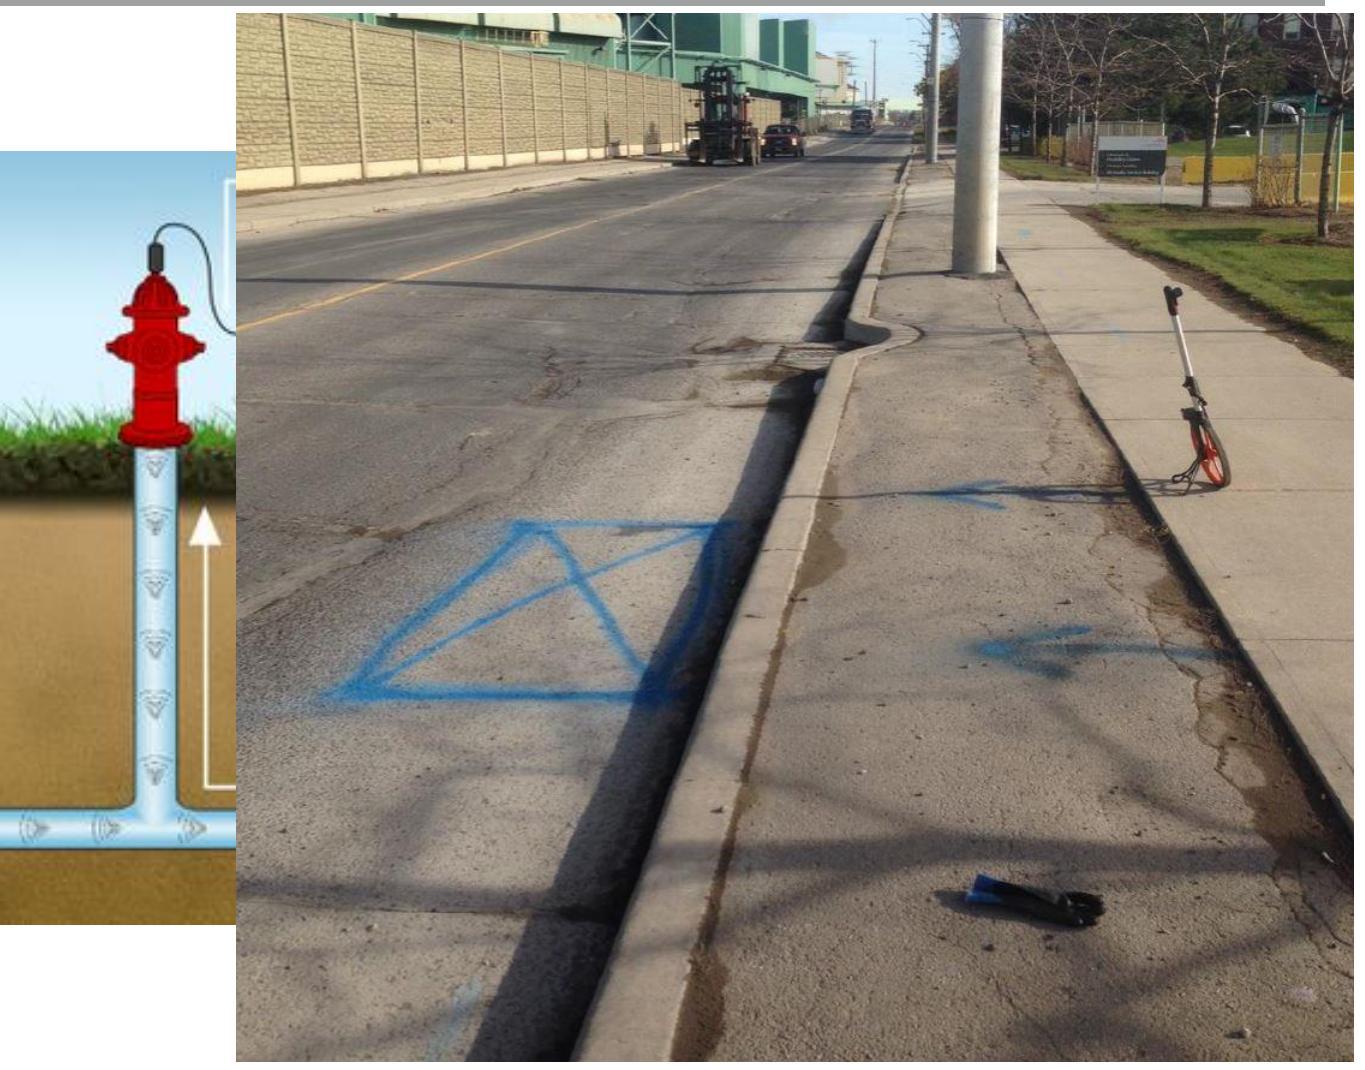
- 3 leaks reported
- 1 discovered during repair
- All at joints, all repaired using bellend clamp

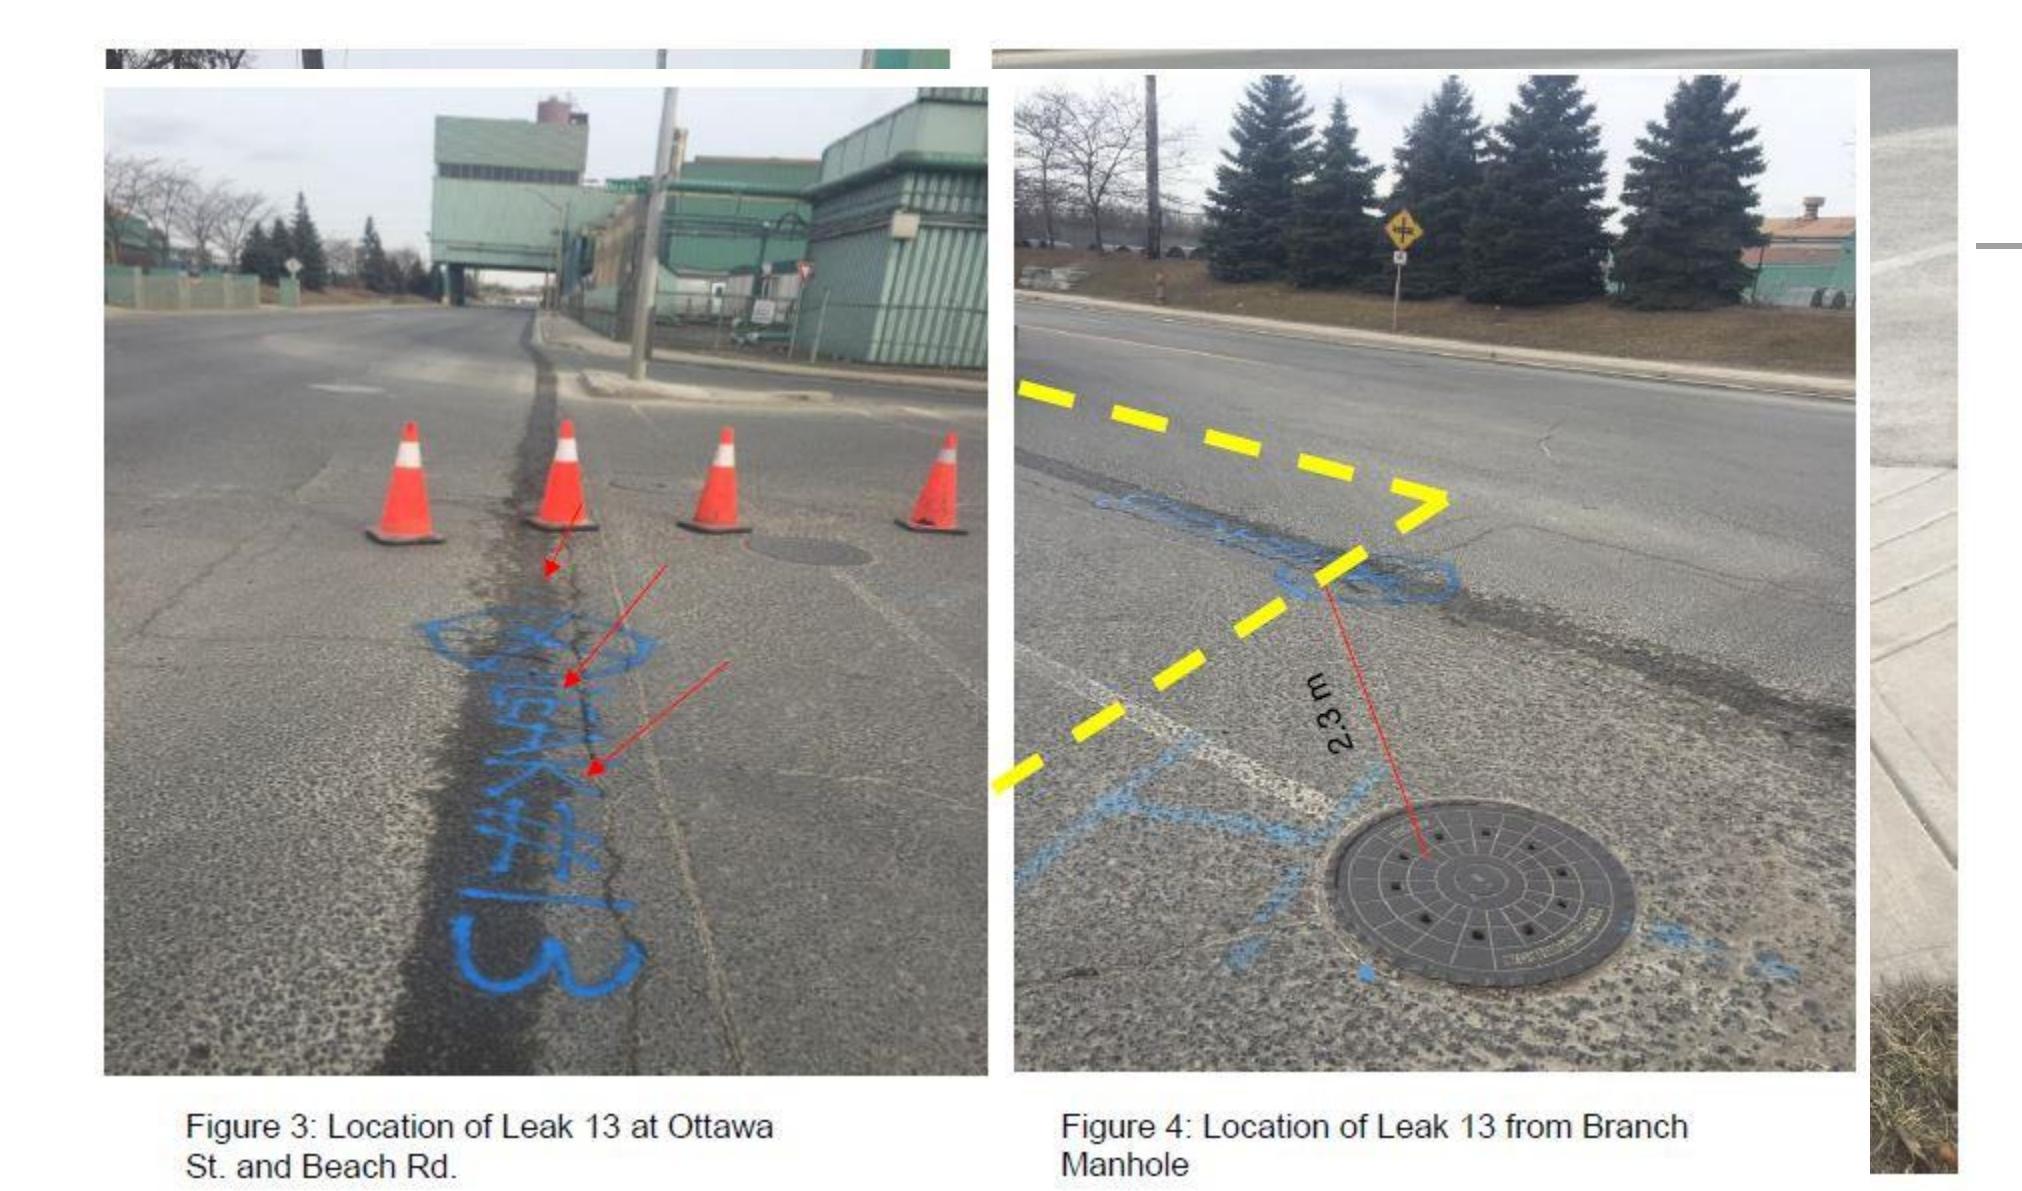
· · · ·			Description of Leak
#8	273.8 metres after Drain Valve #HB21V008 (SBR 6 at 28+54)	Small (~1.8L/min)	Joint
#9**	339.8 metres after Drain Valve #HB21V008 (SBR 6 at 28+54)	Medium (~11.8L/min)	Suspected Feature (cross)
#10	497.7 metres after Drain Valve #HB21V008 (SBR 6 at 28+54)	Small (~1.9L/min)	Joint
#11**	514.9 metres after Drain Valve #HB21V008 (SBR 6 at 28+54)	Small (~4.2L/min)	Joint
#12	536.9 metres after Drain Valve #HB21V008 (SBR 6 at 28+54)	Medium (~7.9L/min)	Joint
#13**	<b>478.2 metres</b> before Air Valve #HB19V060 (SBR 8 / Extraction at 39+92)	Medium (~16.6L/min)	~2m before the ~80- deg Bend from Beach Rd onto Ottawa St N
#14**	<b>426.4 metres</b> before Air Valve #HB19V060 (SBR 8 / Extraction at 39+92)	Small (~4.5L/min)	Joint
<mark>#15</mark>	221.4 metres before Air Valve #HB19V060 (SBR 8 / Extraction at 39+92)	Small (~2.9L/min)	Joint
