# Managing 100 year old Pipeline

A City of Hamilton Case Study

#### The Beach Rd 900mm diameter Watermain

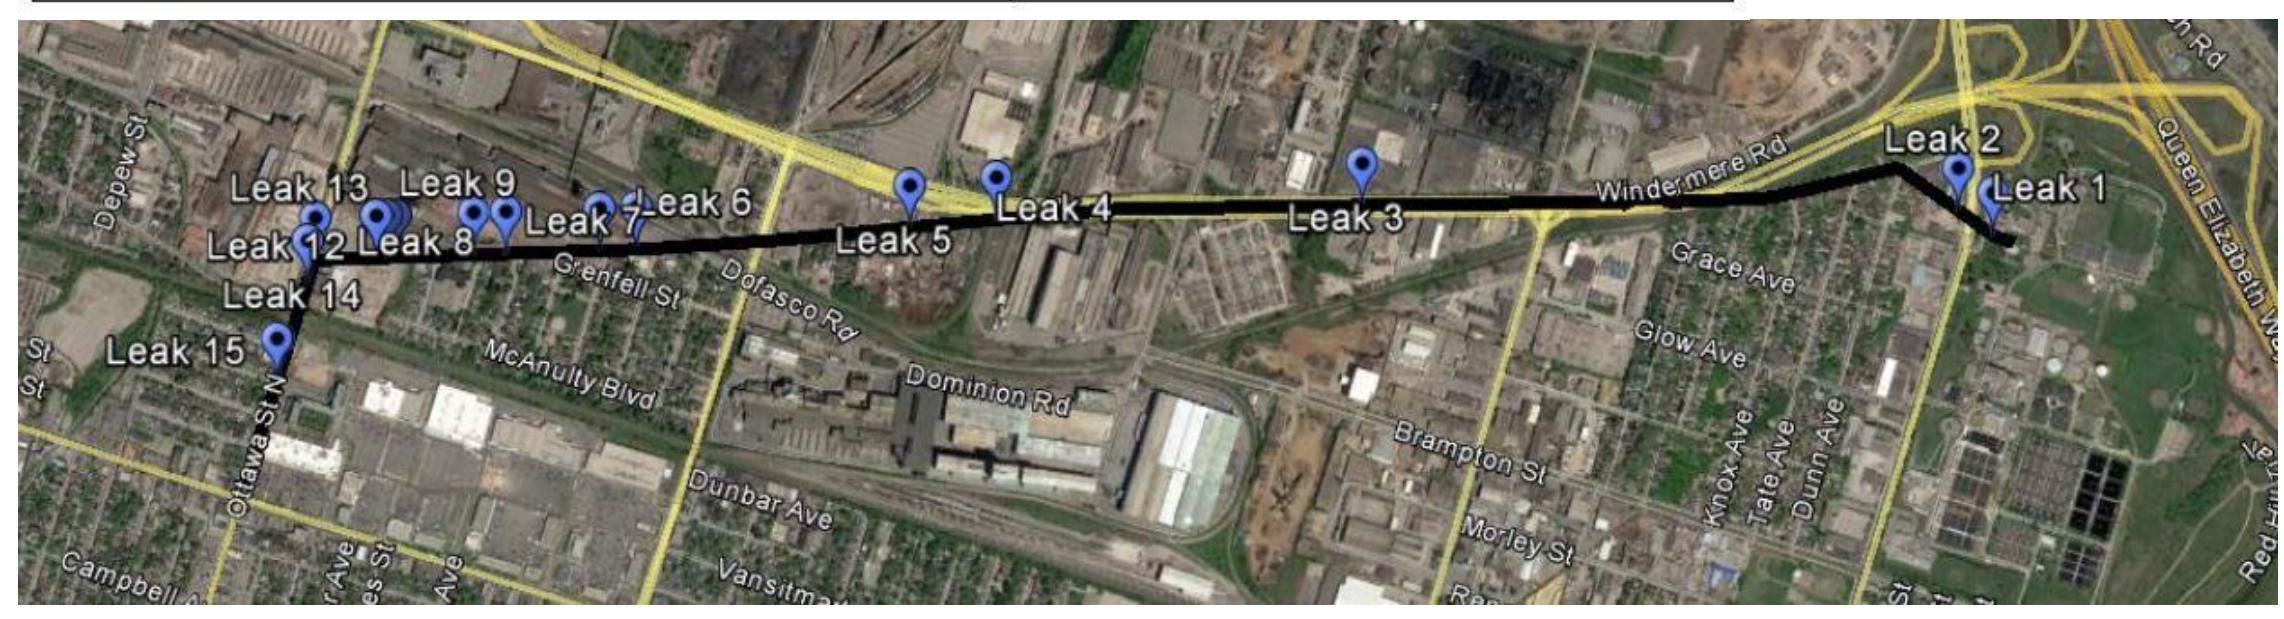
Table 1.2: SmartBall Inspection Results				
Acoustic Anomalies Characteristic of Leaks:	15			
Total Leak Volume (Approximate):	107 L/min			
Acoustic Anomalies Characteristic of Pockets of Trapped Gas:	0			
Duration of the Inspection:	2 hours and 46 minutes			
Average SmartBall Tool Velocity:	0.4 m/s

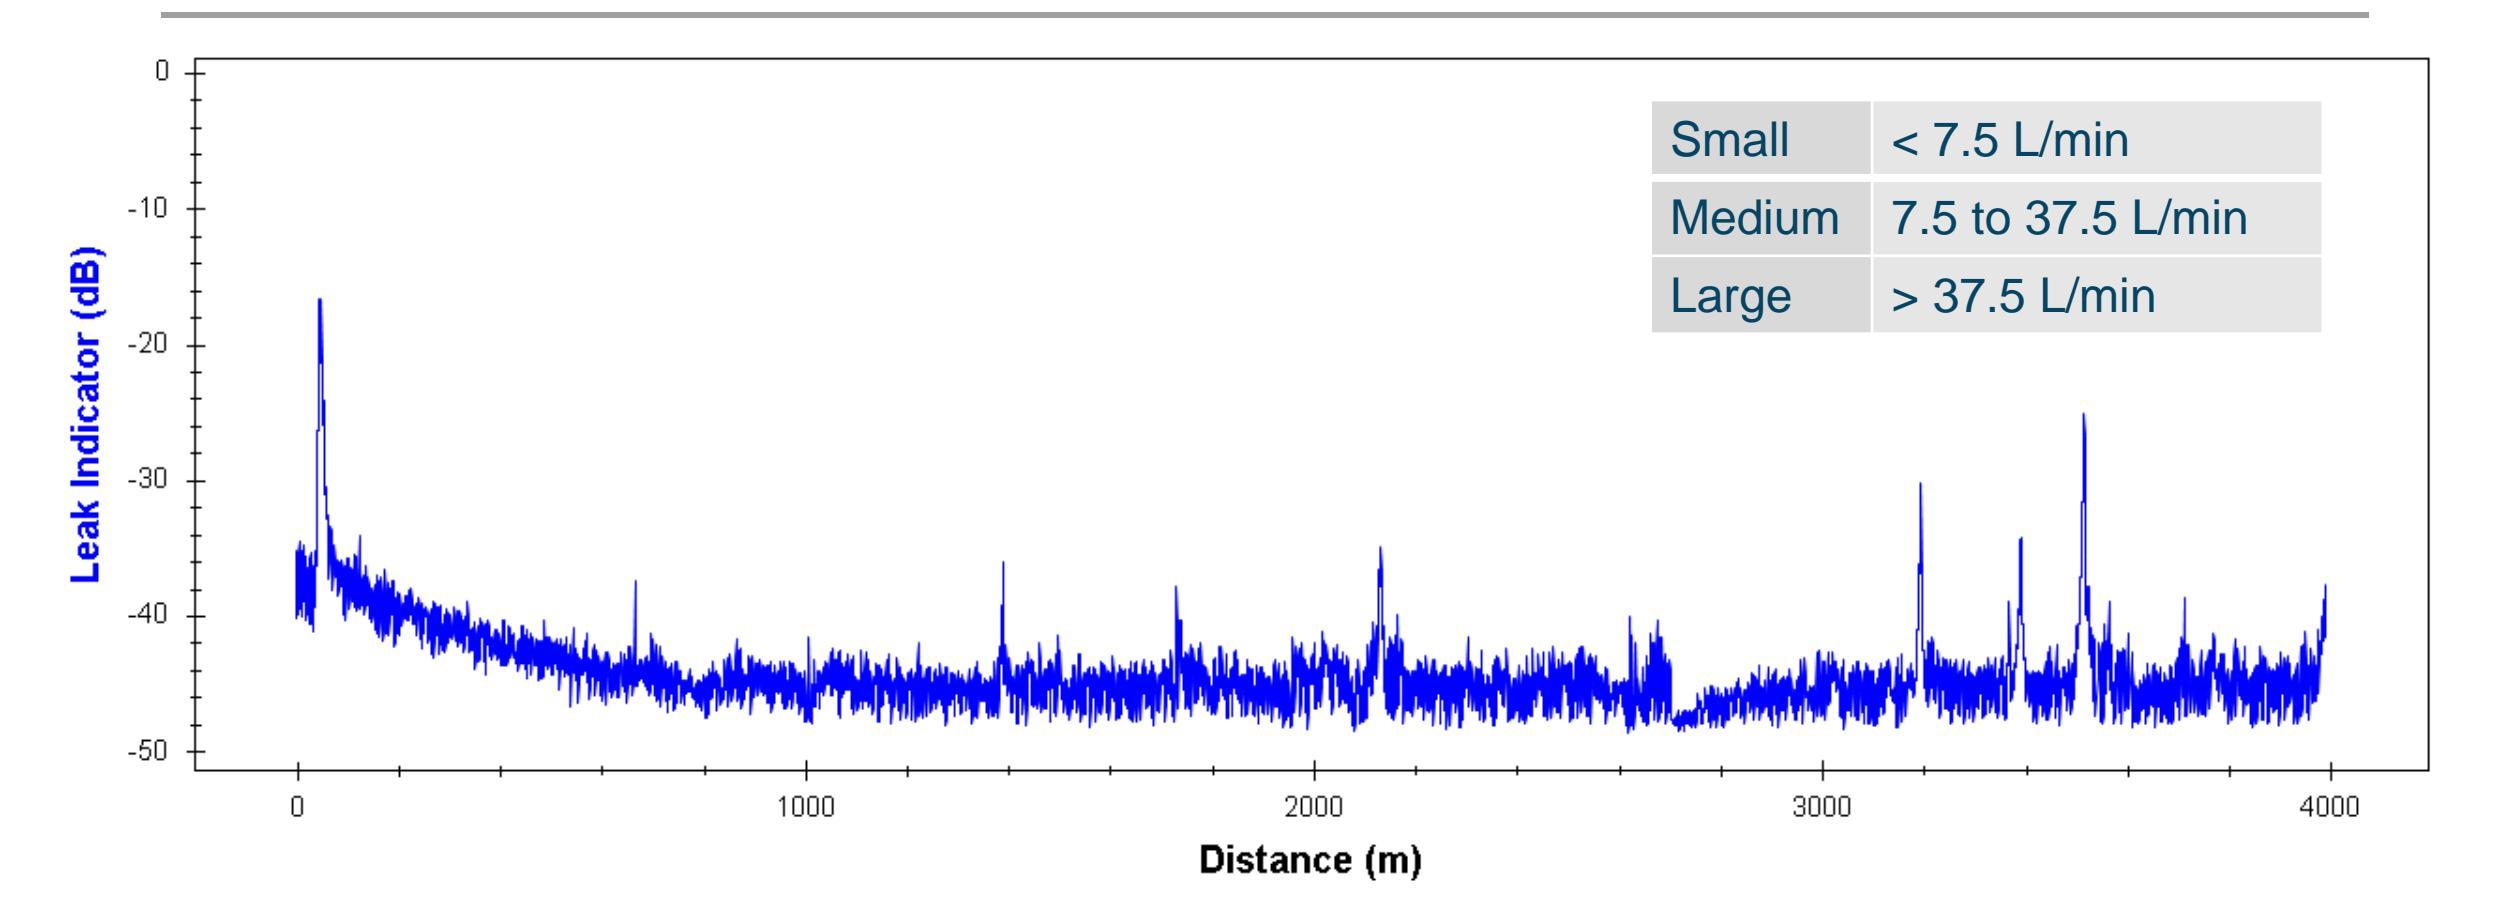
· · · ·			Description of Leak
#8	273.8 metres after Drain Valve #HB21V008 (SBR 6 at 28+54)	Small (~1.8L/min)	Joint
#9**	339.8 metres after Drain Valve #HB21V008 (SBR 6 at 28+54)	Medium (~11.8L/min)	Suspected Feature (cross)
#10	497.7 metres after Drain Valve #HB21V008 (SBR 6 at 28+54)	Small (~1.9L/min)	Joint
#11**	514.9 metres after Drain Valve #HB21V008 (SBR 6 at 28+54)	Small (~4.2L/min)	Joint
#12	536.9 metres after Drain Valve #HB21V008 (SBR 6 at 28+54)	Medium (~7.9L/min)	Joint
#13**	<b>478.2 metres</b> before Air Valve #HB19V060 (SBR 8 / Extraction at 39+92)	Medium (~16.6L/min)	~2m before the ~80- deg Bend from Beach Rd onto Ottawa St N
#14**	<b>426.4 metres</b> before Air Valve #HB19V060 (SBR 8 / Extraction at 39+92)	Small (~4.5L/min)	Joint
<mark>#15</mark>	221.4 metres before Air Valve #HB19V060 (SBR 8 / Extraction at 39+92)	Small (~2.9L/min)	Joint
